Archives of Current Research International

Coastal Geo-environmental Hazards and Its Management

Original Research Article

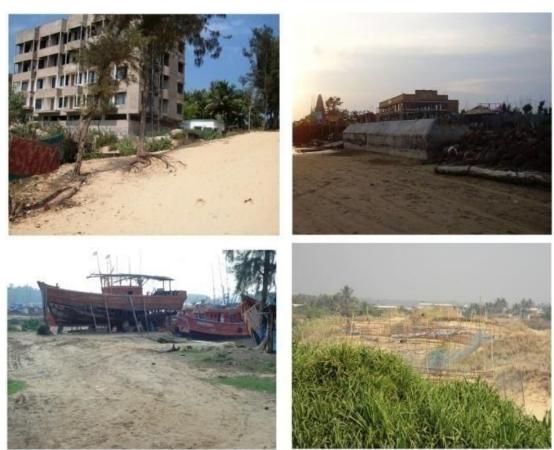
Fig. 7. Recently sand dunes are suffered greatest degree of various human processes

Sand dunes are topographical height in the lowlying coastal plain of west Bengal. At present, of the entire coastal ecosystem, sand dunes have suffered greatest degree of human processes. Many dune systems have been irreversible altered through the activities of man, both by accident and design. Ecosystem components of the sand dunes are affected by the intensive use of dunes in the coast. Artificial structures like houses, hotels, fishery etc are disturbing the normal growth of the dunes and removal of sand by road cutting; grazing on the dune of Shankarpur - Mandarmani areas (Fig. 7). The level of grazing pressure is instrumental in determining species composition and dune plants are destroyed by growth of urbanisation. agriculture and costal defence programme. On the coast over the last 20th years the large scale of tourism-related development rapidly increased the dune in Digha, Shankarpur, Tajpur and Mandarmani areas.

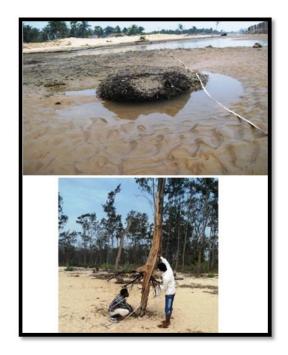
Fig. 8. Thickness of sands are removed from the foreshore by tidal waves and storm surges

Sample nos.	Shankarpur (m)	Chandpur (m)	Mandarmani (m)
1	1.5	.5	.3
2	1.4	.45	.2
3	.96	.6	.4
4	.88	.5	.3
5	1.2	.5	.15
6	.7	.35	.2
7	.8	1.2	.3
8	.65	1	.24
9	.9	.85	.32
References	Casuarina trees, Gurd wall, Clay bank	Embankment, Casuarina trees	Plam trees

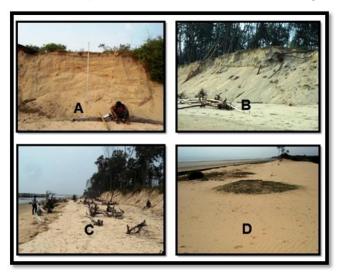
Fig. 10. Removal of frontal dunes and dunes barrier by shoreline recession

by shoreline recession, reduction of dune height by wind and high wave action, cliffing at the seaward side of dune barrier and flattening of dune field by northward marching are important morphological changes of dune topography of Kanthi coastal plain at present.
